# Complex Bearing Problem on a Slow Speed Application (96 RPM)

Normally, outer race problems are relatively easy to recognize in a vibration spectrum. This case study shows an example of an outer race problem on a concrete breaker.

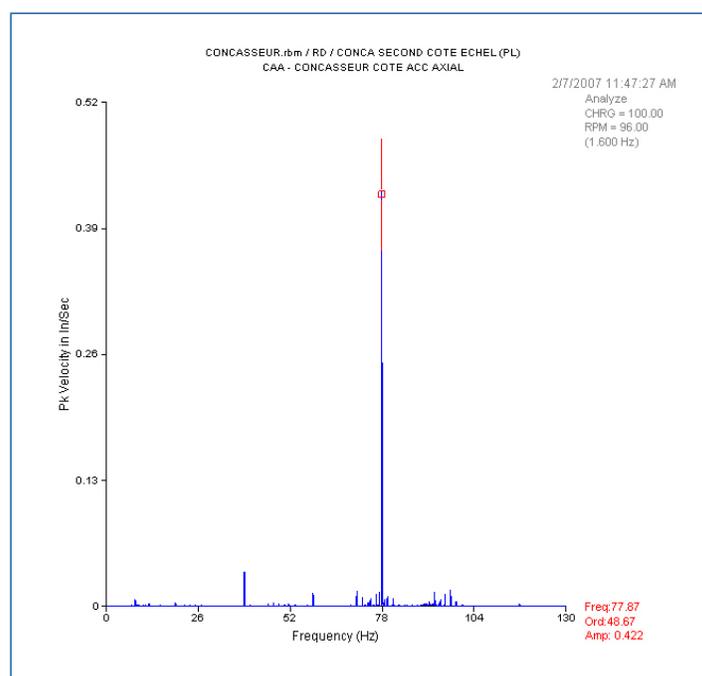
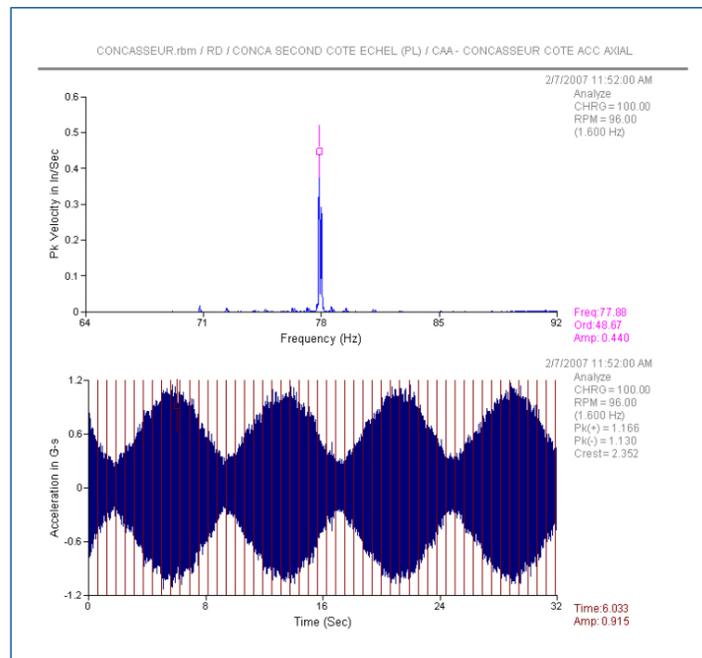
The installation is a concrete breaker. 2 motors with a speed of 740 RPM are connected with a belt to roll with a speed of 100 RPM.

On 7 February 2007, a very high frequency was measured at 78 Hz on a rotor in axial direction.

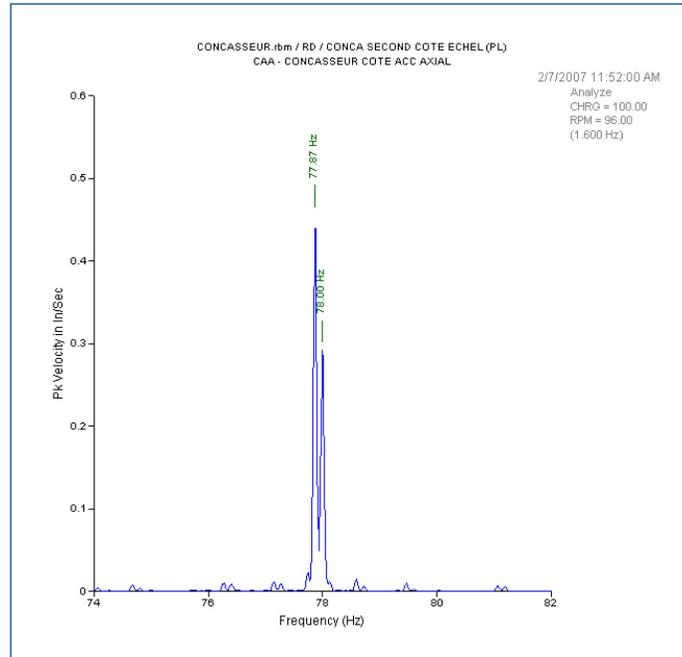
A detail measurement tells us that this frequency, in reality, is the combination of 2 frequencies, very close to each other. 1 peak is at 77.87 Hz and the other is at 78.0 Hz

Those 2 peaks are creating a beat frequency. This is also easy to recognize in the associated waveform.

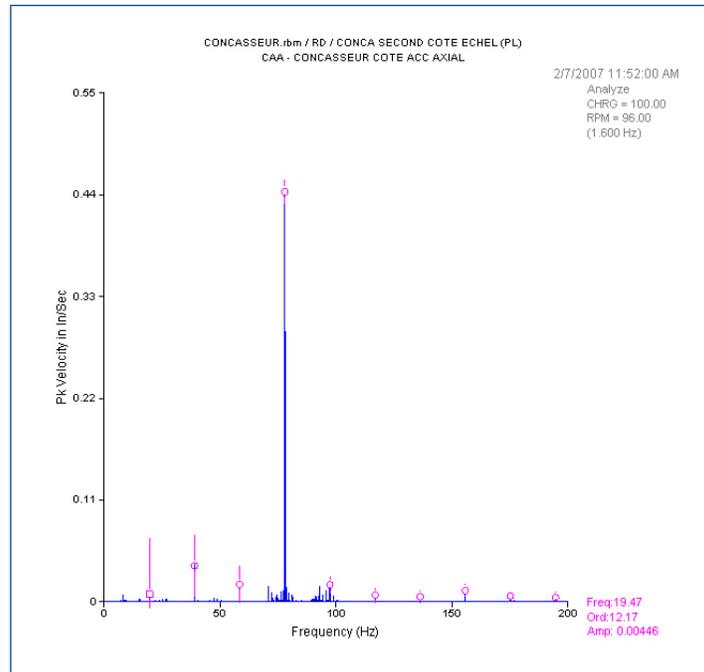
High resolution measurements show that the peak at 78 Hz is not a standalone peak, but is in fact the 4th harmonic of a family at 19.5 Hz. This is the BPFO frequency of the installed bearing (bearing number is 24060B).

So, we know now that this is an outer race problem. But why is the 4th harmonic so high, and where is the beat frequency coming from?

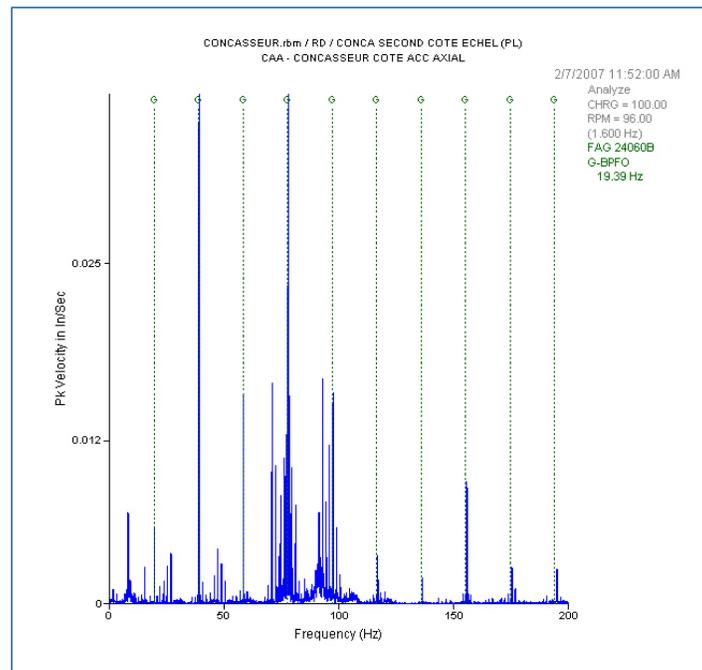
When we take a closer look at the spectrum in the neighborhood of 78 Hz, we see an increased floor level, which can be an indication of a structural resonance frequency. In other words, the 4th harmonic of the outer race problem has such high amplitude because it is amplified with a structural resonance.

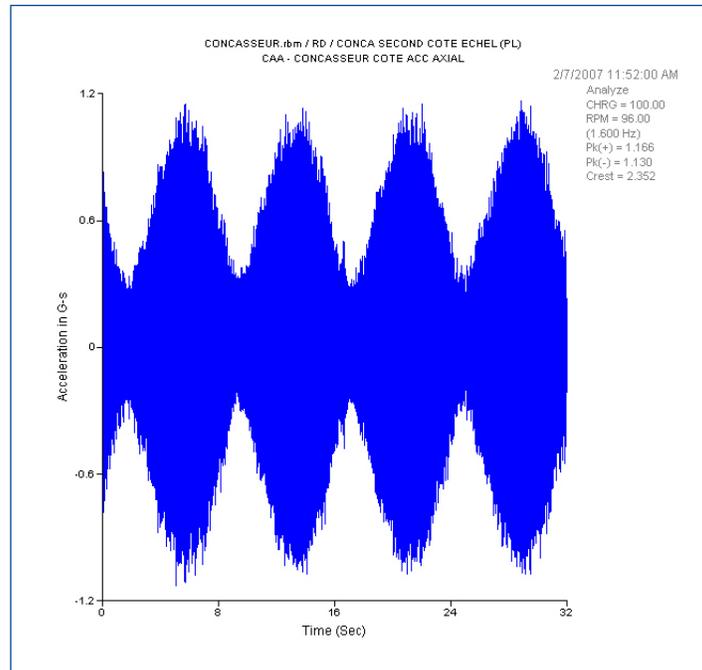
A closer look at the spectra shows us that there are 2 harmonic families in the spectrum, one at 19.47 Hz and one at 19.50 Hz. If we want to explain the beat frequency at 77.87 Hz and 78.0 Hz, we have to find an explanation of 19.47 Hz and 19.50 Hz.

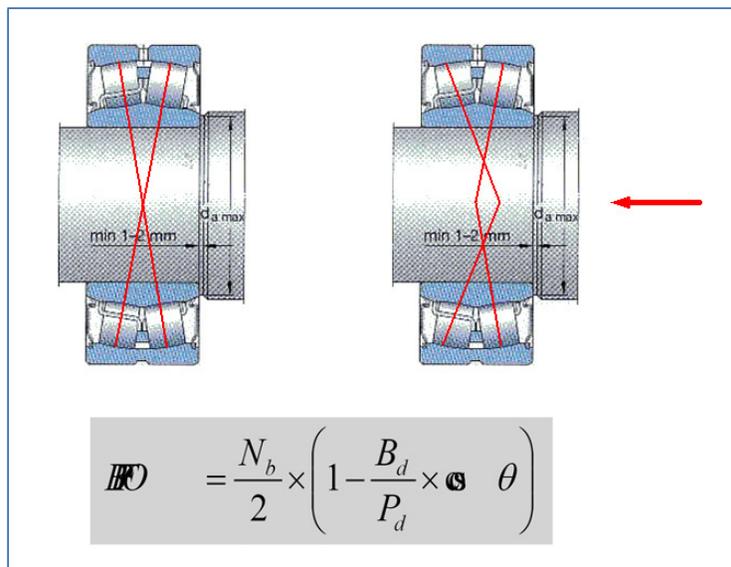
The combination of a resonance problem with an outer race problem and an installation problem created this extraordinary waveform.

Here is a picture of the damaged bearing.

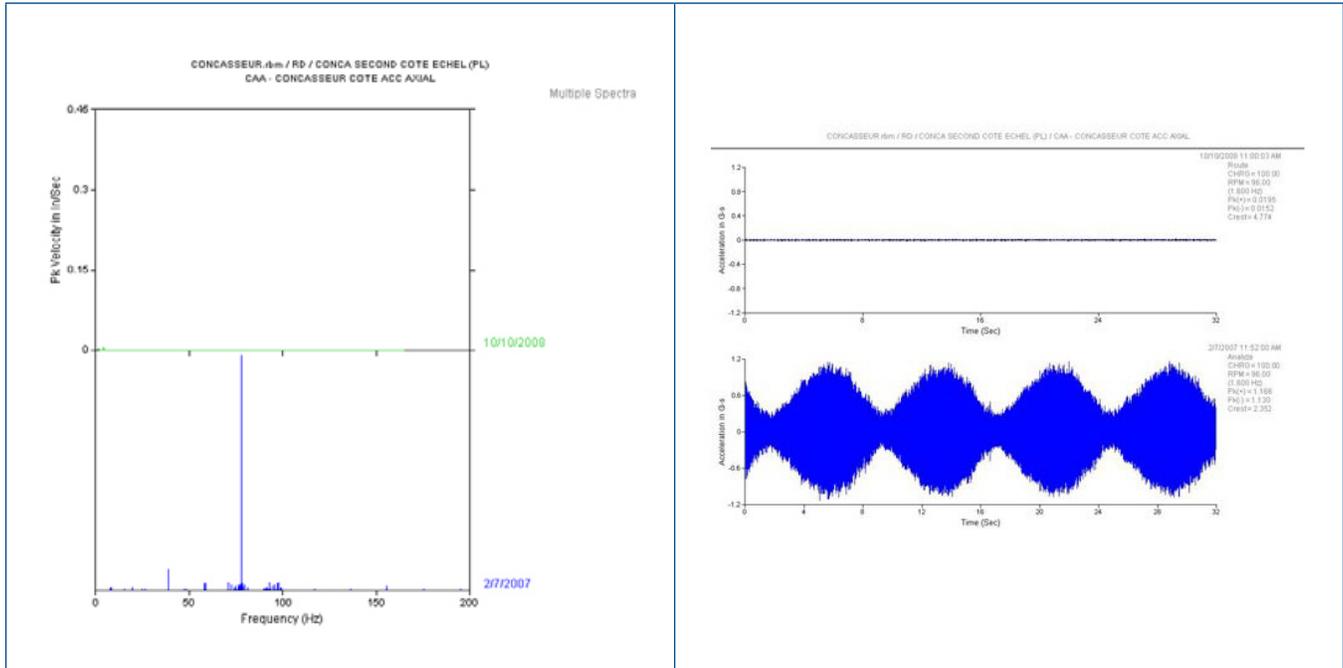
The last pictures show a comparison of the spectra and waveforms before and after the bearing replacement.
