ICE CREAM PRODUCTION PLANT REDUCES MAINTENANCE AND IMPROVES QUALITY WITH VIBRATING FORK TECHNOLOGY

Ice Cream Production Plant in Europe

Level detection of ammonia in ice cream freezers

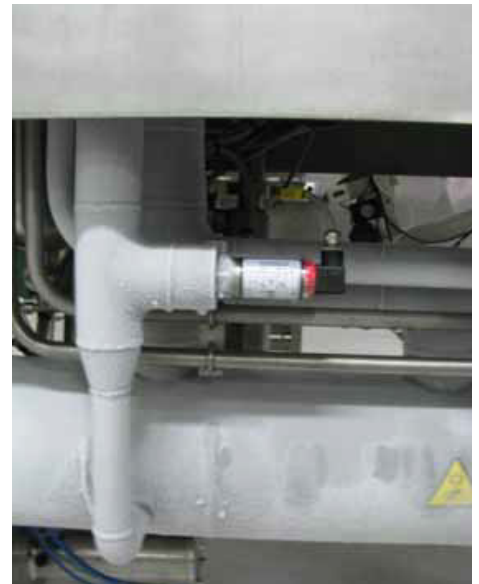
Figure #1: Installed Rosemount™2110 Compact Vibrating Fork Level Switch

This customer installed a Rosemount 2110 Vibrating Level Switch to replace the previously incompatible technology and provide reliable ammonia level detection. The rugged stainless steel design of the Rosemount 2110 enables it to operate in low ambient temperatures and fulfill the requirements of IP66/67. Additionally, the transmitter Heartbeat LED gives status and health information to ensure that the electronics are unaffected by the harsh ammonia environment.
